**SUBJECT: Response to SEPA DNS Letter Dated June 27, 2022
SeaTac Hotel & Apartments
File #SPR-21-0002/SEP21-0002, Ecology SEPA #202202996
SeaTac, Washington**

**Re: Phase II Environmental Site Assessment
Jet Motel Property
17234 to 17300 International Boulevard
SeaTac, Washington
19159-00**

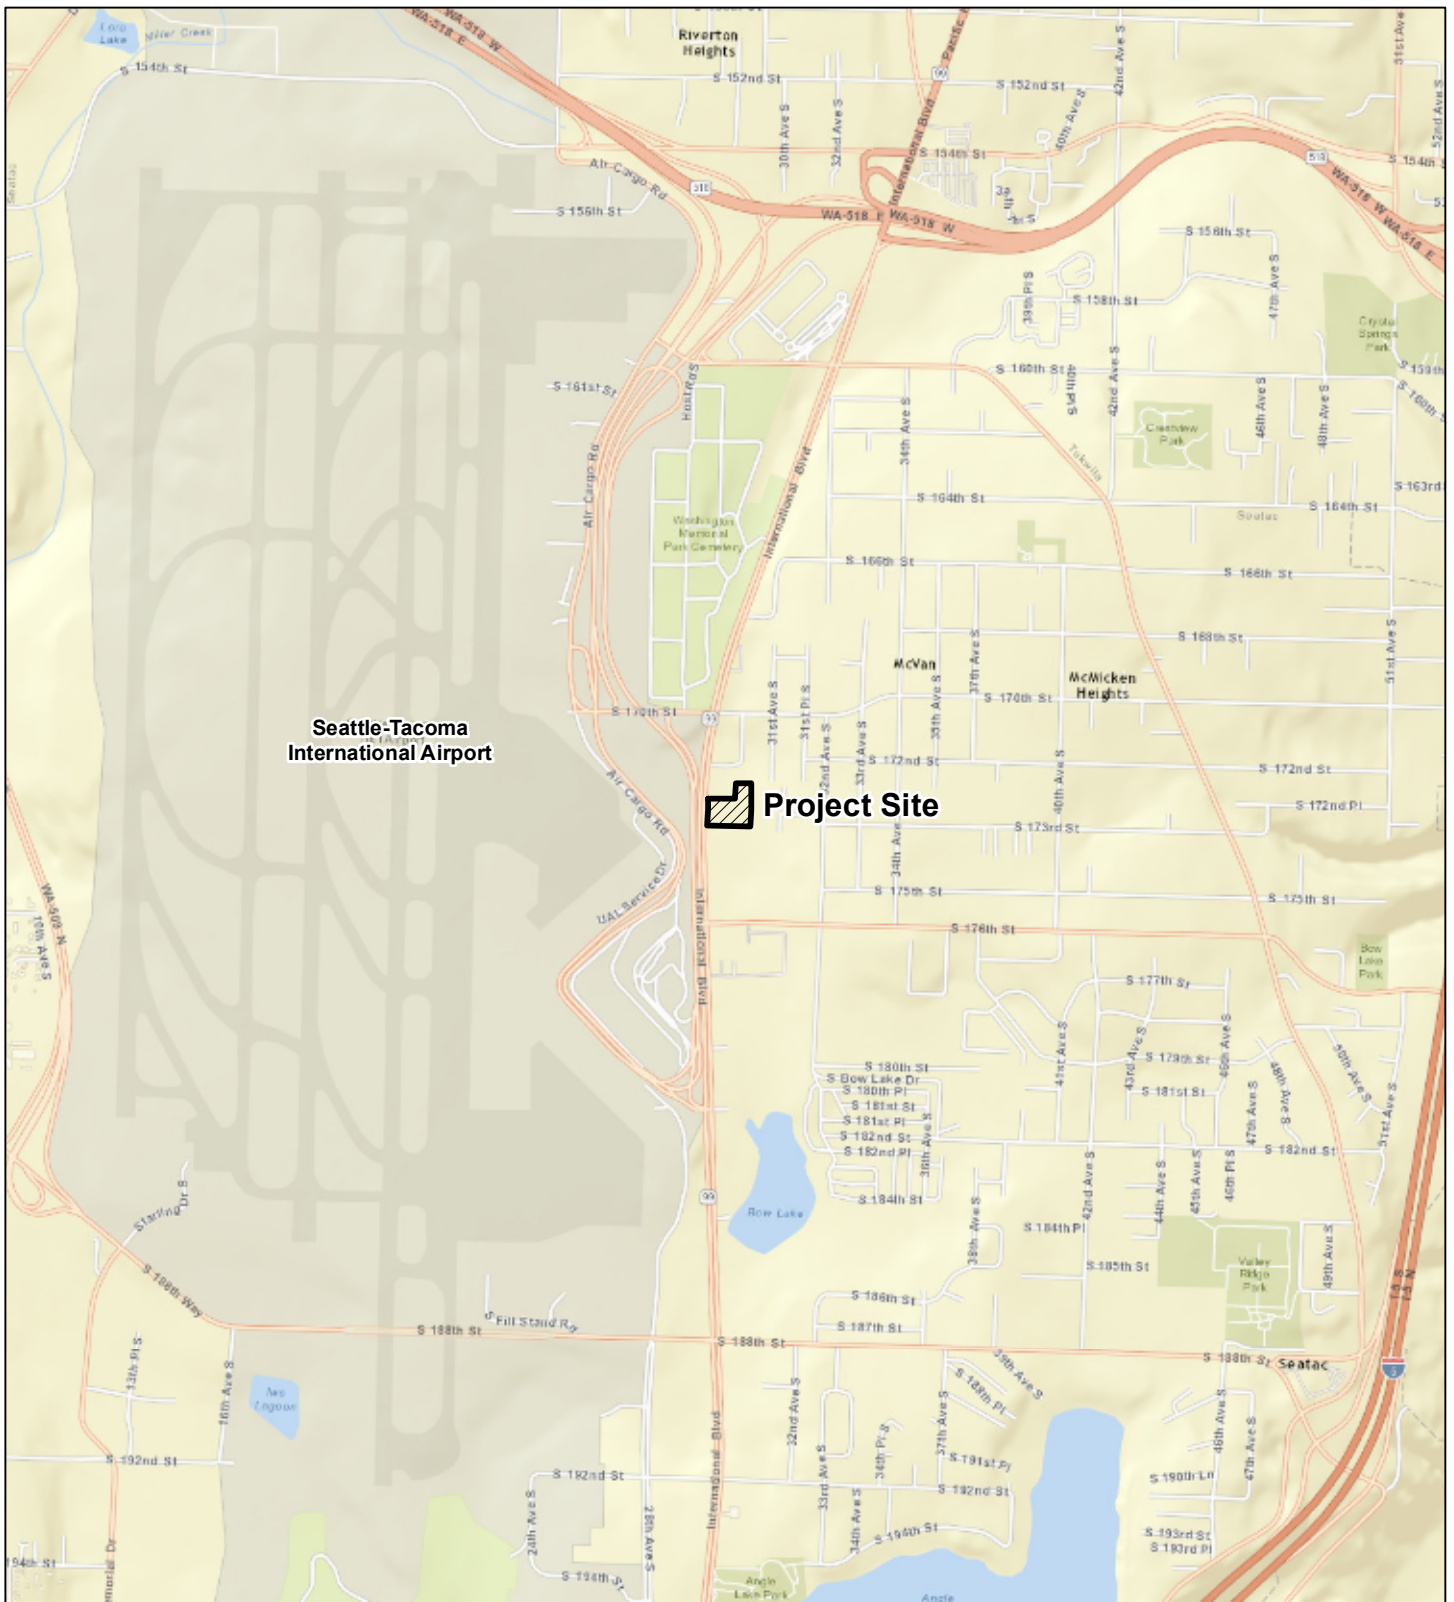
Soil analytical results are summarized in Table 1. Figure 1 is a vicinity map showing the location of the property. A site plan showing site features and exploration locations is presented on Figure 2. Field methods and exploration logs are in Appendix A. The chemical data quality review and laboratory reports are in Appendix B.

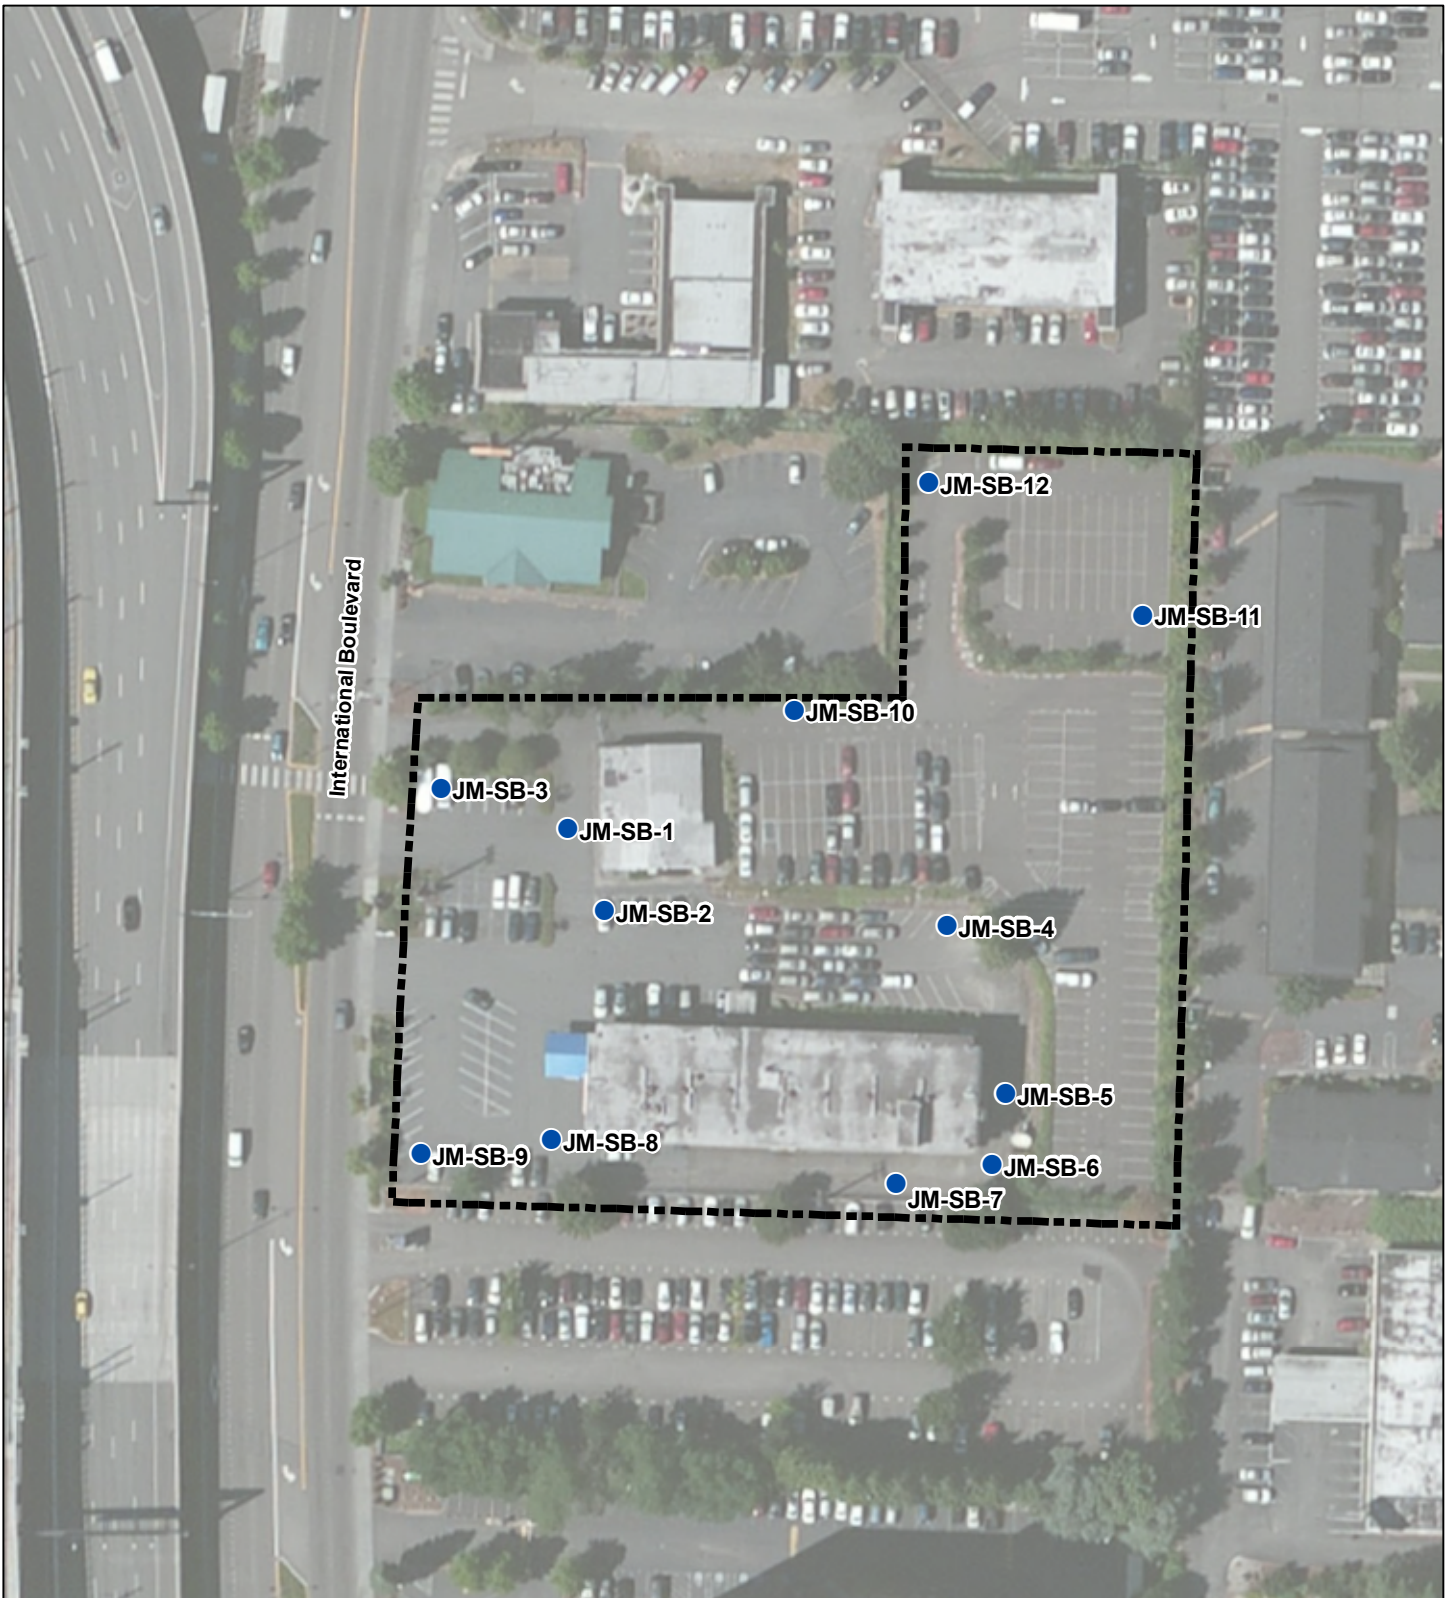
On July 9, 2015, 12 push-probe explorations (JM-SB-1 through JM-SB-12) were advanced to 10 to 15 feet below ground surface (bgs) at the subject property (Figure 2). During the push probe explorations, soil

12 push probe explorations (JM-SB-1 through JM-SB-12) were advanced on July 9, 2015, to depths of 10 to 15 feet below ground surface. The push probe explorations used a 2-inch-diameter probe and were advanced with a truck-mounted rig subcontracted by Hart Crowser. A field representative from Hart Crowser continuously observed the probing and collected the samples using a plastic sleeve sampler pushed by the push probe rig. Sample liners were made of heavy-duty clear acetate plastic for convenient inspection of the soil sample. Soil samples were generally collected at 5-foot depth intervals. Samples were classified in general accordance with ASTM D2488. Push probes JM-SB-1 through JM-SB-12 were screened for potential soil contamination. Detailed logs for each probe are on Figures A-2 through A-13 at the end of this appendix.
