TECHNICAL INFORMATION REPORT
Full Drainage

TARMAC HEIGHTS APARTMENTS
16016 34th Ave. South
SeaTac, WA 98188

PROFESSIONAL ENGINEERING SERVICES, LLC

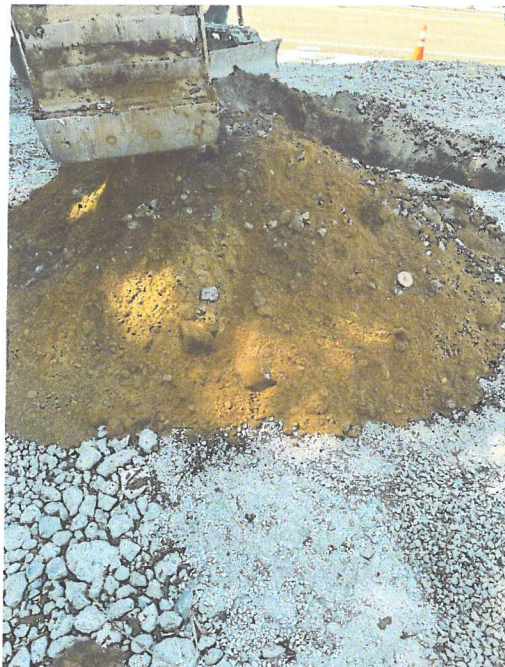
SOIL LOG 2 PHOTOGRAPH

SL-2
0 – 36” **SILTY SAND**
36” – 84”+ **COARSE SAND (PRETTY CLEAN)**
NO GROUNDWATER INDICATORS

SOILS AT OTHER LOGS SIMILAR

Three soil logs were prepared on the site on May 3, 2023. The logs are:
